Subject: **MX Z X 440®  
Calibration/Warranty†**

No. **2005-2**

Subject: **600 HO SDI Recalibration Update**

No. **2005-3**

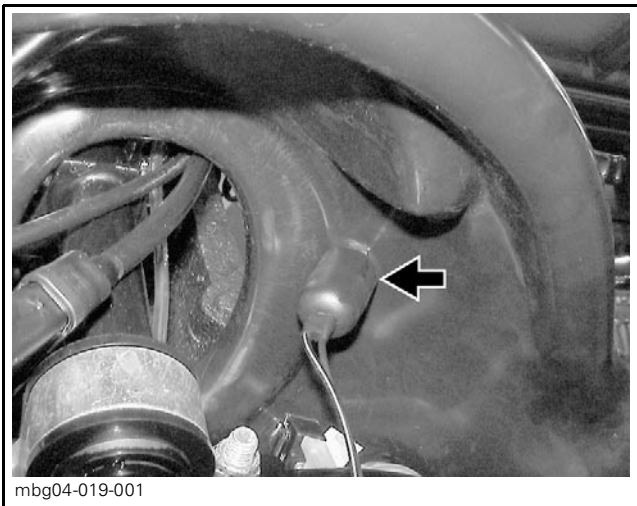
On some vehicle, the rear console may be cracked, because of a wrong tether cut-out switch installation.

- Replace the rear console only if it is cracked.

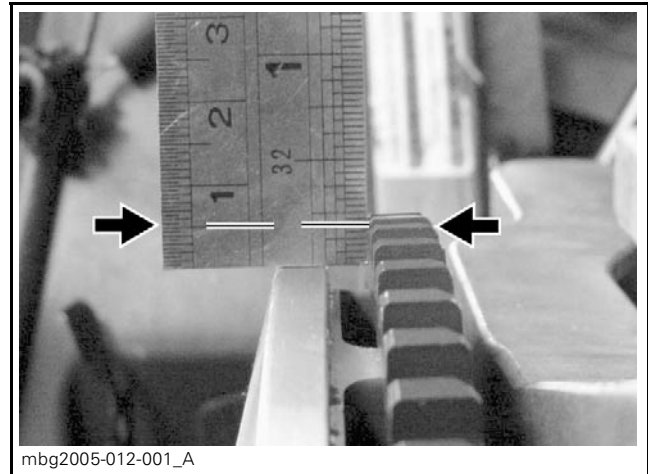
mbg2005-012-001\_A

### Inappropriate Ring Gear

- An inappropriate ring gear needs replacement.
- Do a warranty claim for "Inspection" and "Replacement".

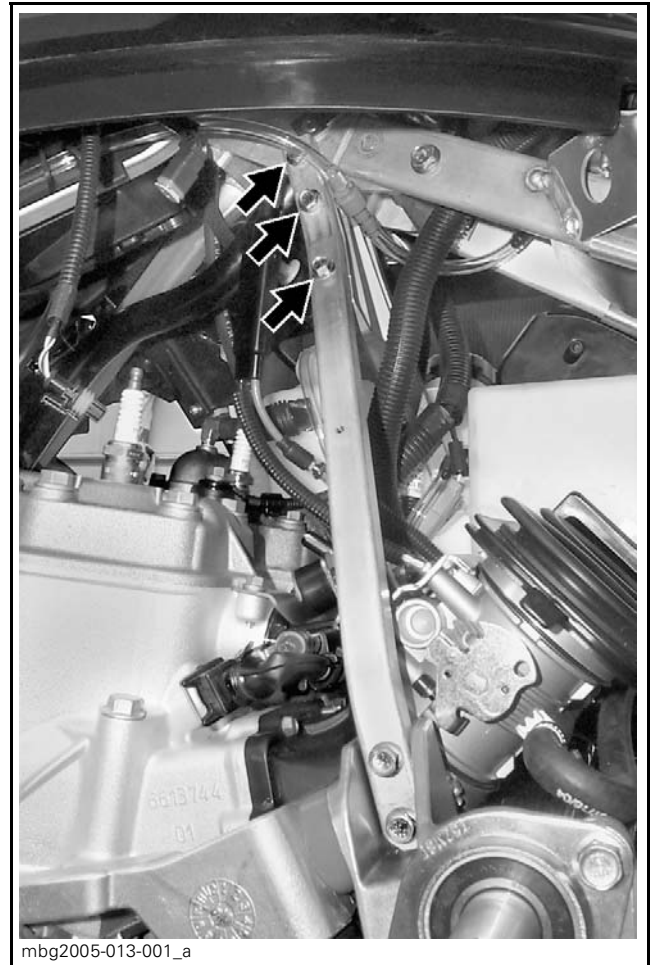
Pyramidal frame bolts may become loose.

To maintain hole alignment while replacing the six bolts on top of the pyramidal frame member; remove and replace existing bolts one at a time.

Replace existing bolts with new bolts with nylon patch
