Campaign no. 99001

No. **99-1**

Date: November 26, 1998

SUBJECT: Pick-Up Wire

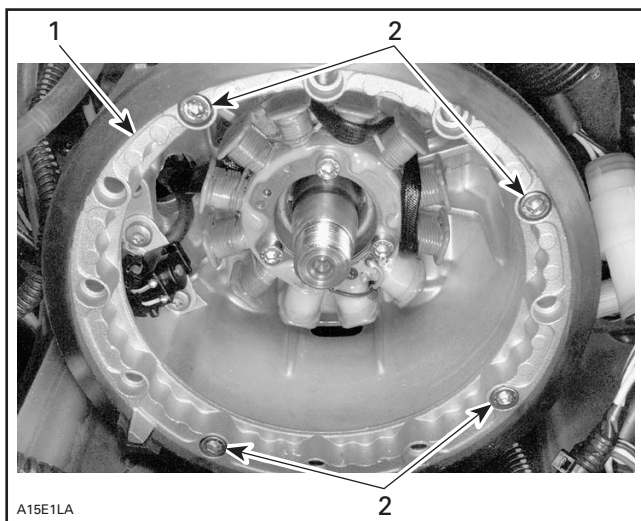
1. Connecting flange
2. Remove these screws

NOTE: Allen key with ball type end is ideal to remove left lower screw of connecting flange.

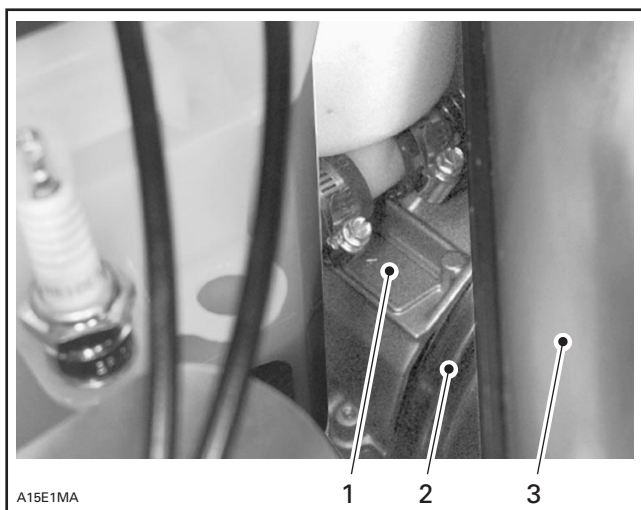
1. If visual inspection reveals that distance between wire and magneto flywheel is sufficient, 2 mm (5/64 in) or more, reinstall all removed parts and identify unit as "done" with an X in rectangle on top of magneto housing, using a marker.

1. Use this space on top of magneto housing
2. Rewind cover
3. Tuned pipe

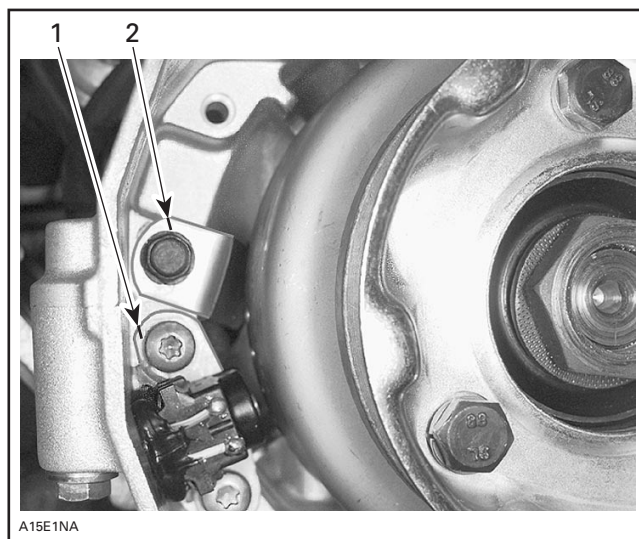
Using already existing hole in casting secure pick-up wire with bracket and self-tapping screw, apply Loctite 242 (blue) (P/N 293 800 015) on screw and torque to 10-12 N•m (7-9 lbf•ft). Note that bracket must be installed with its lower edge in contact with top of pick-up bracket. Refer to following photo.

1. Pick-up bracket
2. Wire bracket in contact with top of pick-up bracket

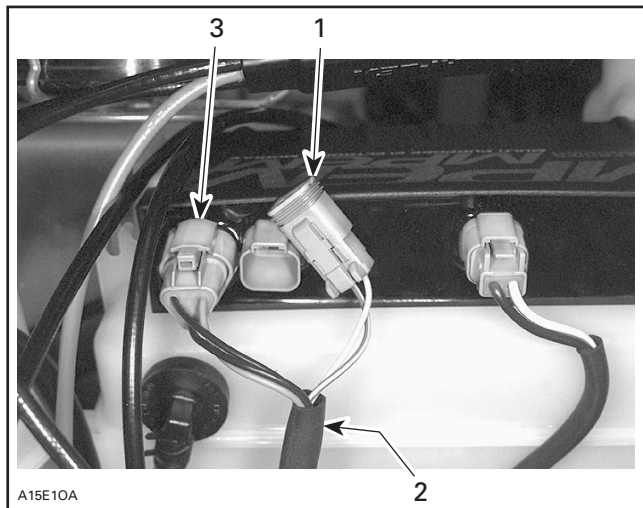
1. Remove this cap
2. Pull wires out of this loom from inside magneto housing
3. Disconnect this connector also

Unscrew pick-up and stator, remove electrical tape around wires at grommet and pull-out pick-up wires from inside protective loom.

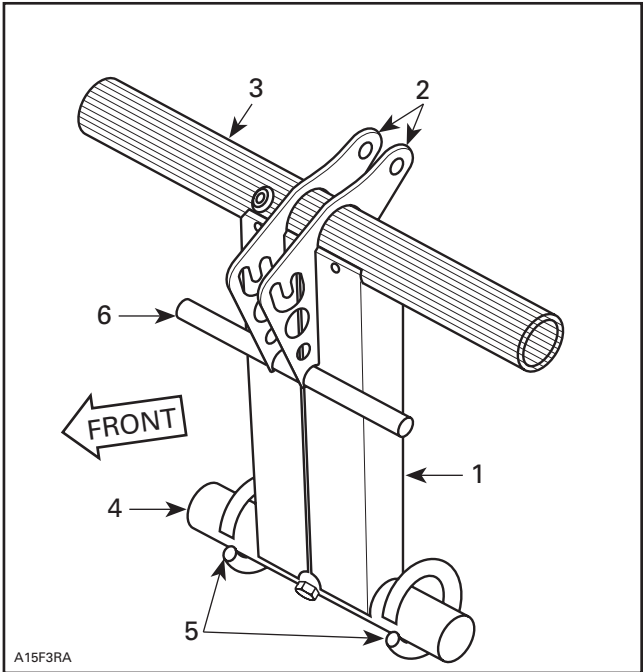
- 1. Welded arm
- 2. Shock absorber support
- 3. Upper tube
- 4. Lower tube
- 5. Tube protector
- 6. Axle

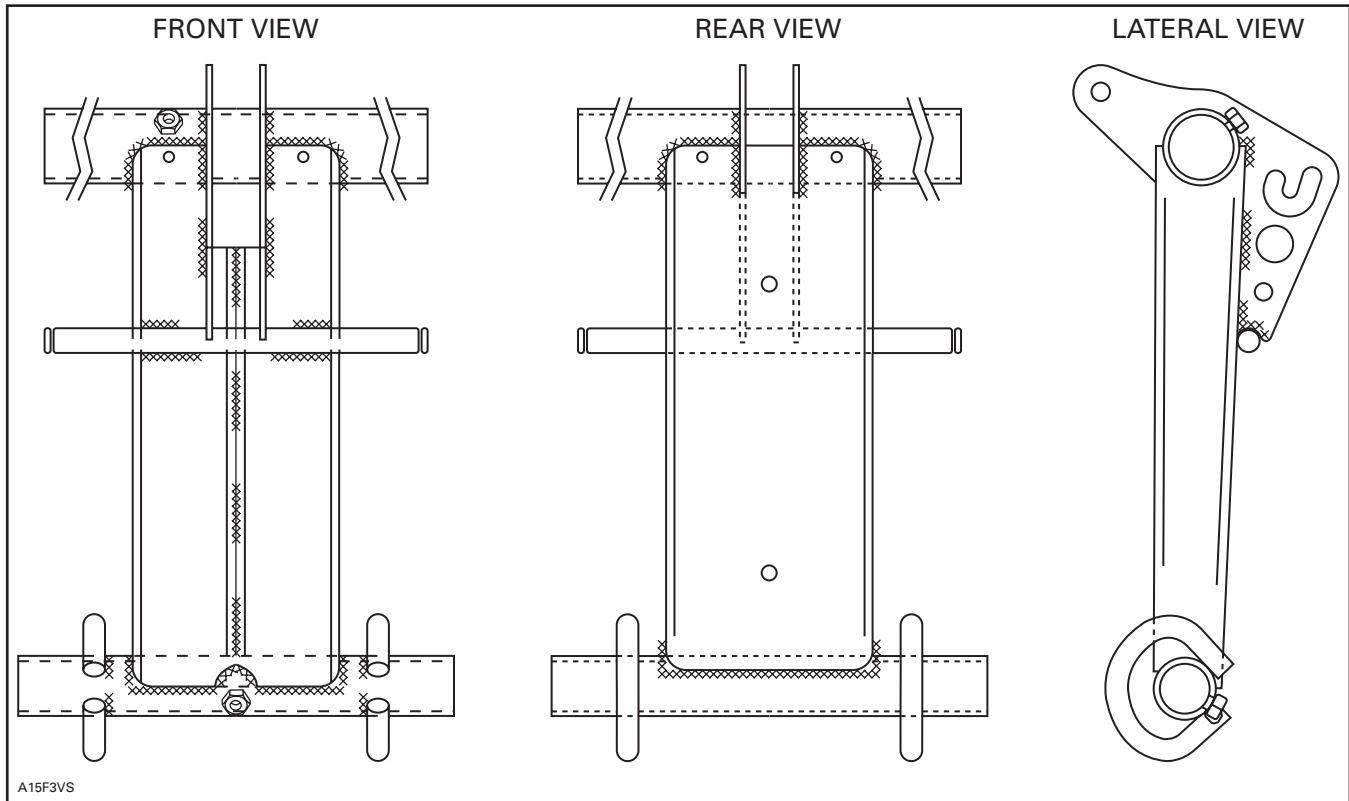
Perform a complete inspection as per following FRONT VIEW, REAR VIEW and LATERAL VIEW illustrations.

WELDING SEAMS ARE SHOWN WITH XXXX

Pay closer attention to following welded seams:

Should a single omission be detected, rear arm must be replaced.

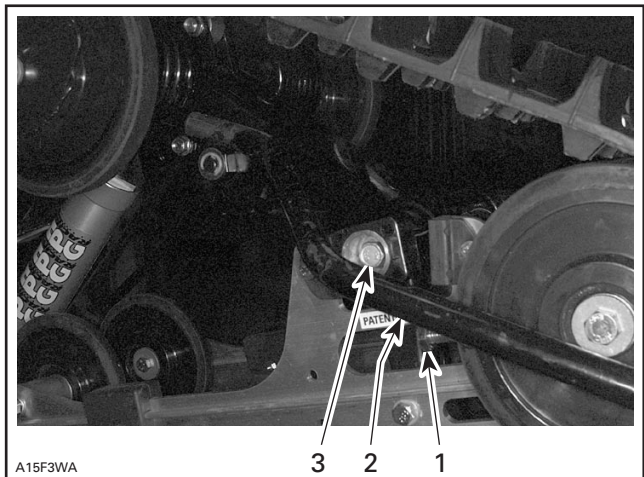
1. Adjuster bolt
2. Tool (P/N 529 005 000)
3. Lower tube retaining bolt

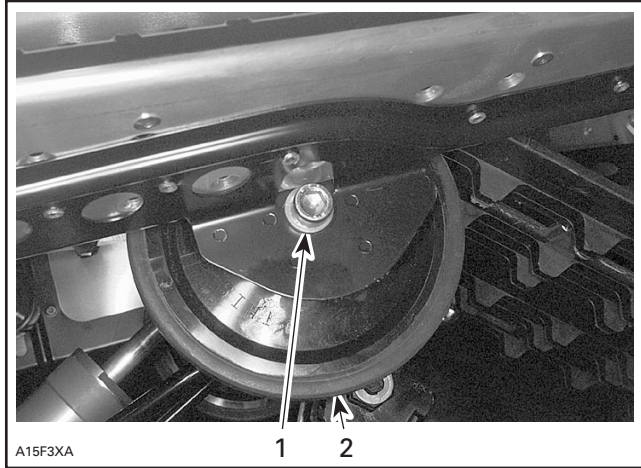
1. Allen bolt
2. Idler wheel

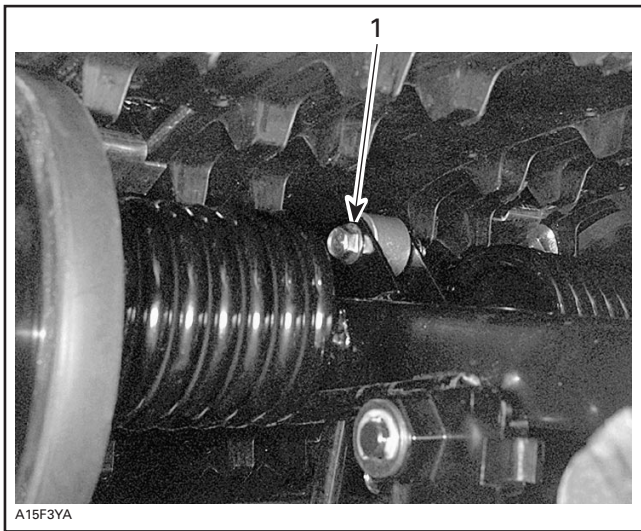
1. Shock absorber upper bolt

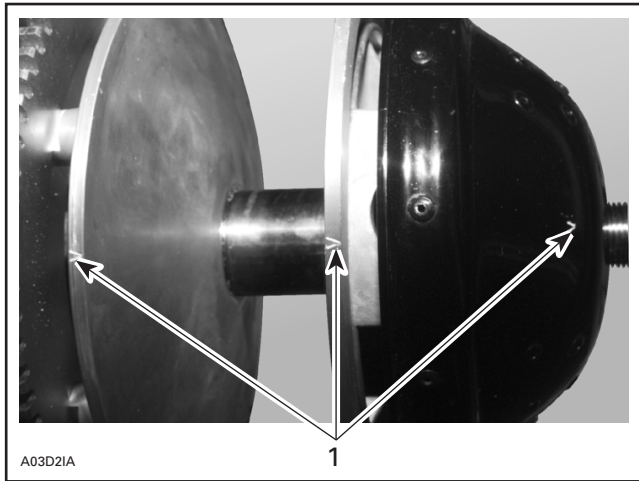
Check for alignment marks for proper indexing at reassembly.

1. Alignment marks

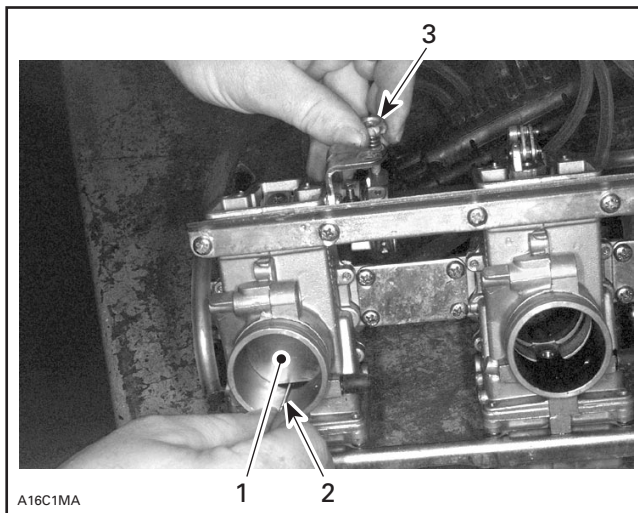
START WITH PTO SIDE CARBURETOR

1. Throttle slide
2. 1.3 mm (0.051 in) bit inserted for proper gap
3. Manual adjustment before tightening screw

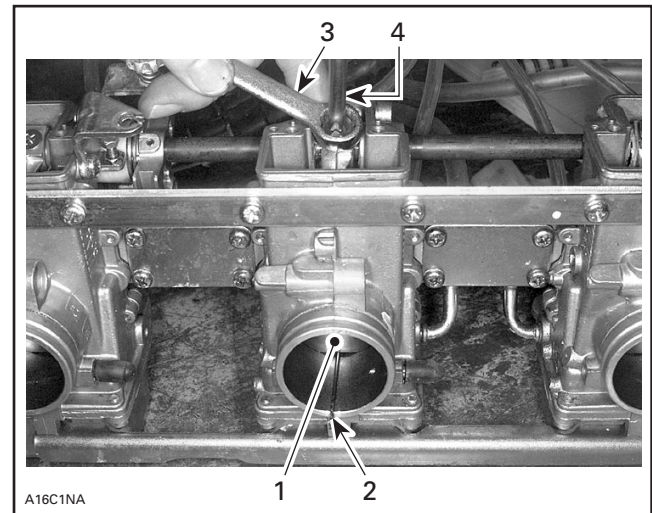
CENTER AND MAG SIDE CARBURETORS

1. Throttle slide
2. 1.3 mm (0.051 in) bit
3. Loosen nut with wrench
4. Tighten or untighten screw with screw driver to obtain proper cut-away height

CAUTION: Make sure all three cut-aways are adjusted according to specification without difference in height. **Failure to do so will cause severe engine damage.**

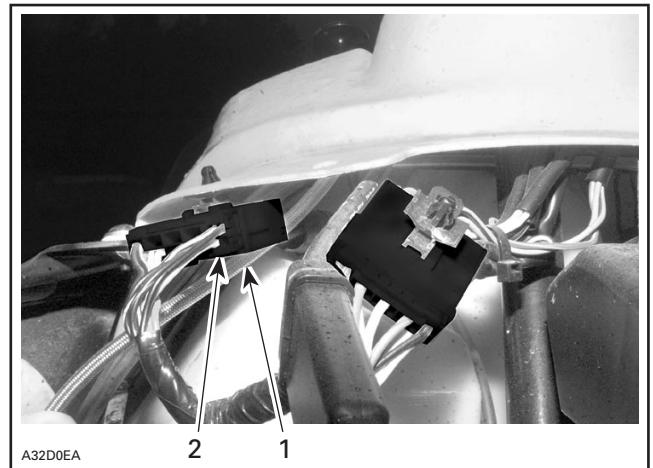
Brake hose may rub on electrical harness located next to steering shaft and wear.

1. Brake hose
2. Potentially faulty harness

- A. Inspect brake hose and electrical harness and relocate brake hose if no sign of wear is found.
- B. Inspect brake hose and if sign of wear is found, replace brake hose, relocate and secure it. Fix harness if needed.

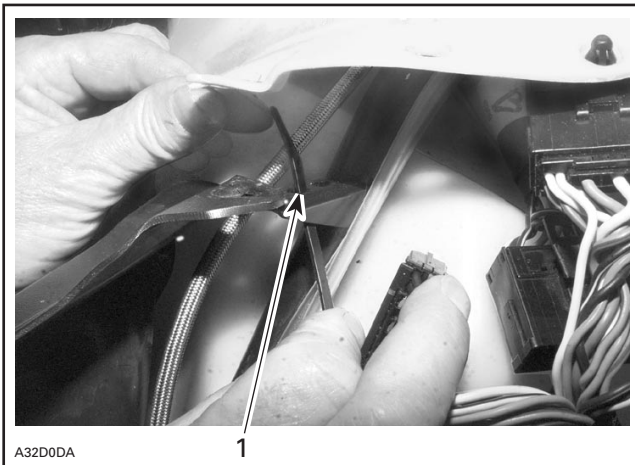
Secure hose using a locking tie and screw center console in place.

1. Locking tie in center hole of bracket

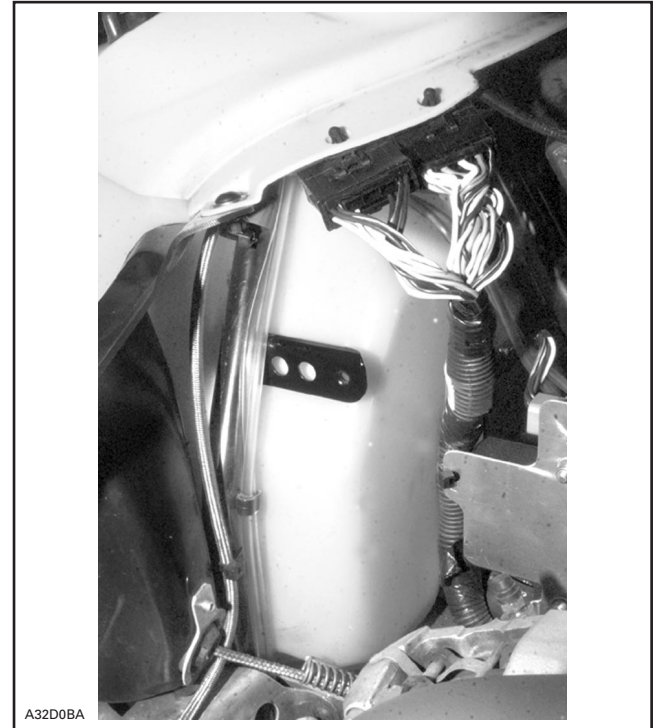
INSTALLATION COMPLETED

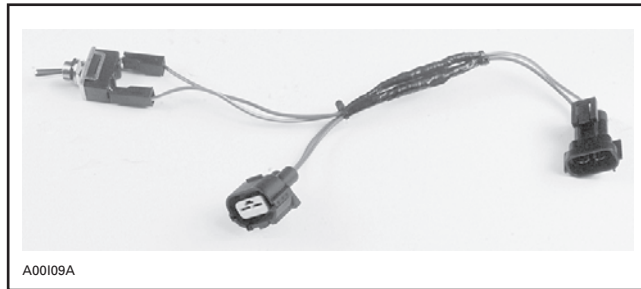
CONNECT BOTH BY-PASS WIRE TERMINAL HOUSINGS TO HARNESS AND MODULE AND TURN ON THE SWITCH

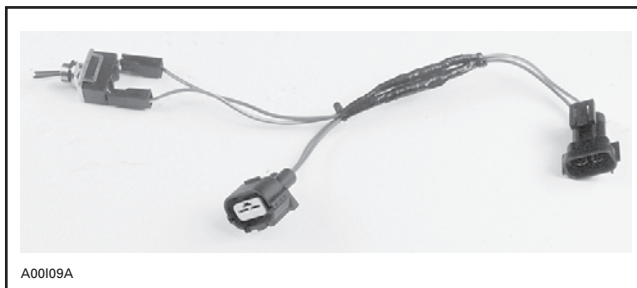
CONNECT BOTH BY-PASS WIRE TERMINAL HOUSINGS TO HARNESS AND MODULE AND TURN ON THE SWITCH

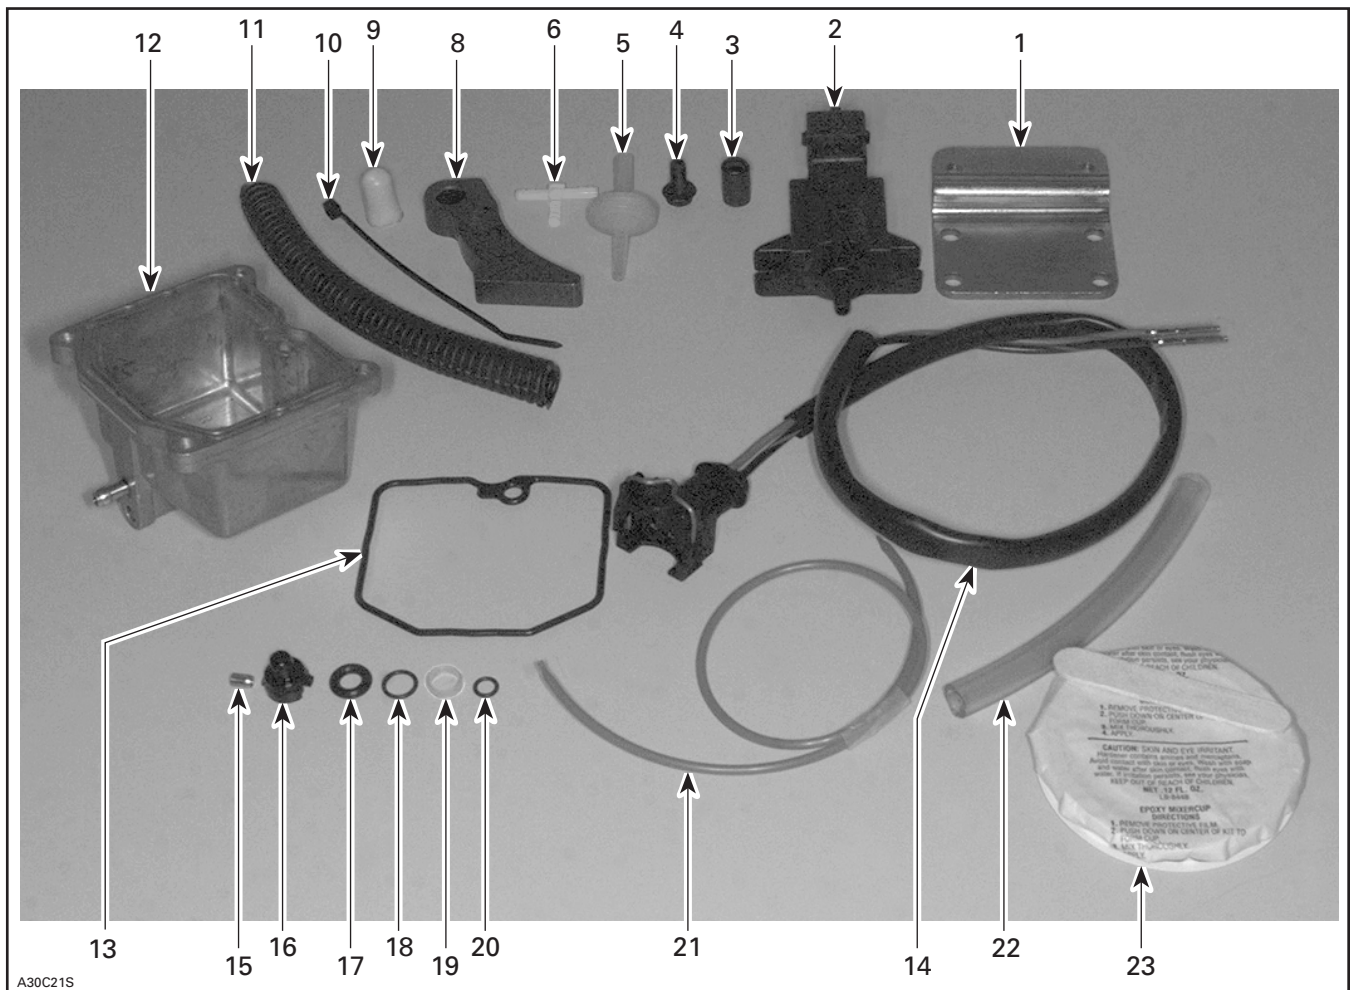
1. Solenoid Plate
2. Solenoid Valve
3. Cap
4. Self-Tapping Screw (2)
5. Check Valve (3)
6. T-Fitting (2)
7. Hose (1 m (39 in)) (not illustrated)
8. Ramp (3)
9. Cap (3)
10. Locking Tie (5)
11. Protector Tubing (125 mm (5 in))
12. Float Body

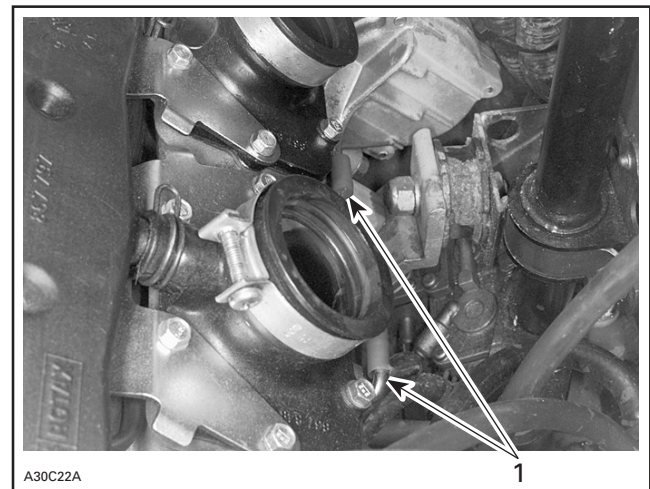
1. 2 impulse fittings on engine

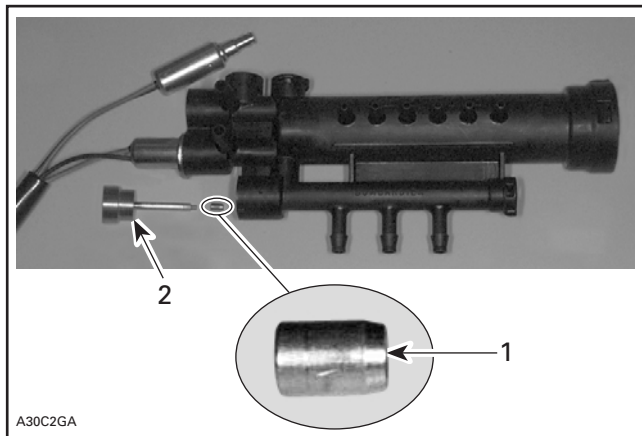
Using DPM compensation jet installer tool (P/N 529 035 722), insert compensation jet **no. 15**, tapered end first, on compensation solenoid side; when tool contacts DPM body, compensation jet is properly seated.

1. Compensation jet no. 15
2. Installer tool

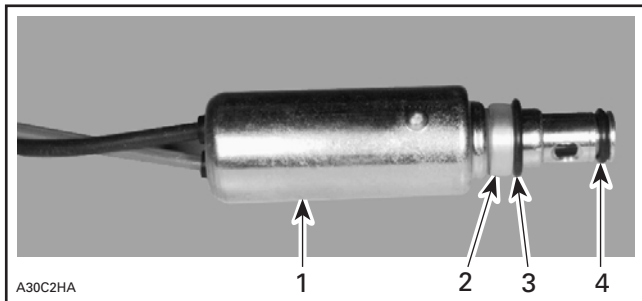
1. Solenoid
2. Plastic spacer no. 19
3. Larger O-ring no. 18
4. Smaller O-ring no. 20

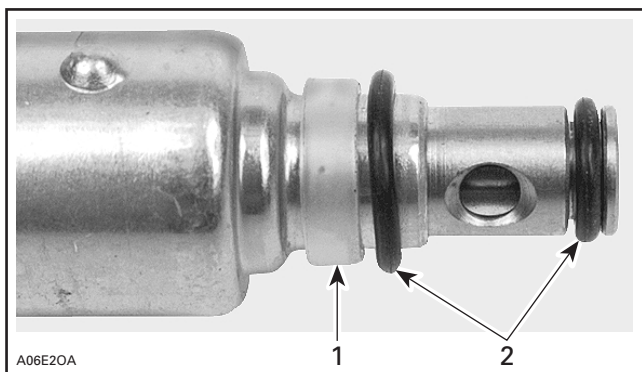
1. Plastic spacer
2. O-rings

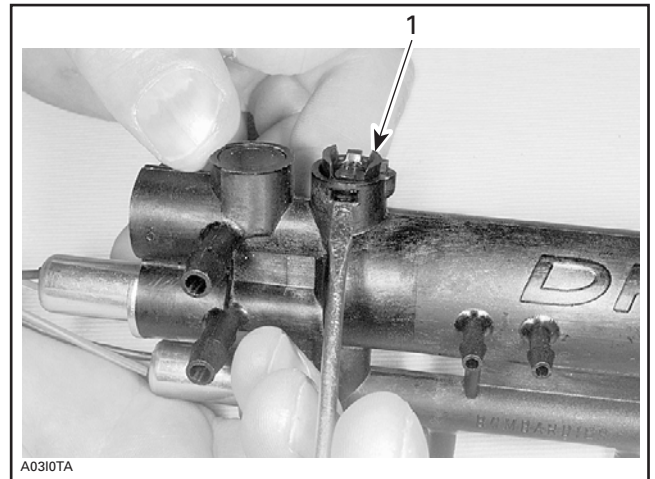
1. Transfer gallery plug

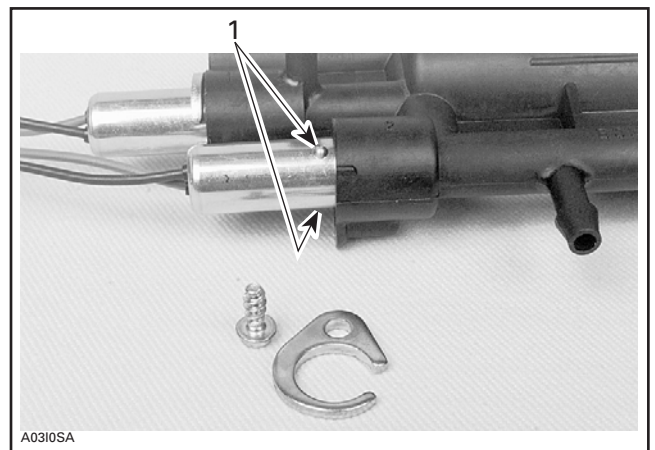
1. Embosses not engaged

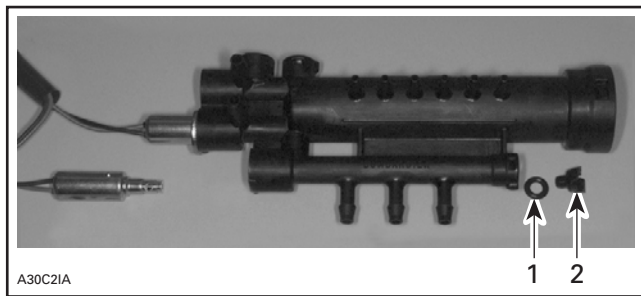
1. End cap O-ring no. 17
2. End cap no. 16

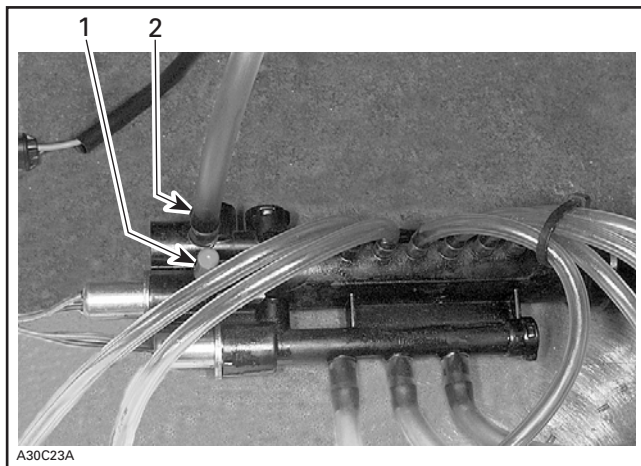
CAUTION: Ensure proper fitting is plugged up otherwise, severe engine damage will occur.

1. Fitting to be plugged up on pressure manifold
2. Vent hose **not to be plugged up nor removed**

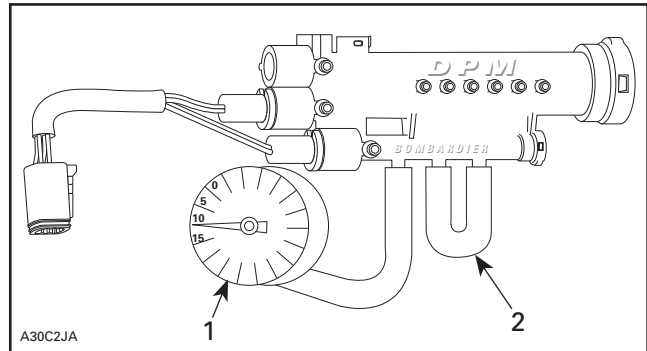
Disconnect all 3 carburetor venturi hoses from DPM. Using tubing **no. 22**, connect 2 carburetor venturi nipples together as per following illustration and proceed with air tightness test by connecting tester onto third nipple; must hold 5 PSI vacuum for 10 seconds.

1. Tester
2. Tubing no. 22

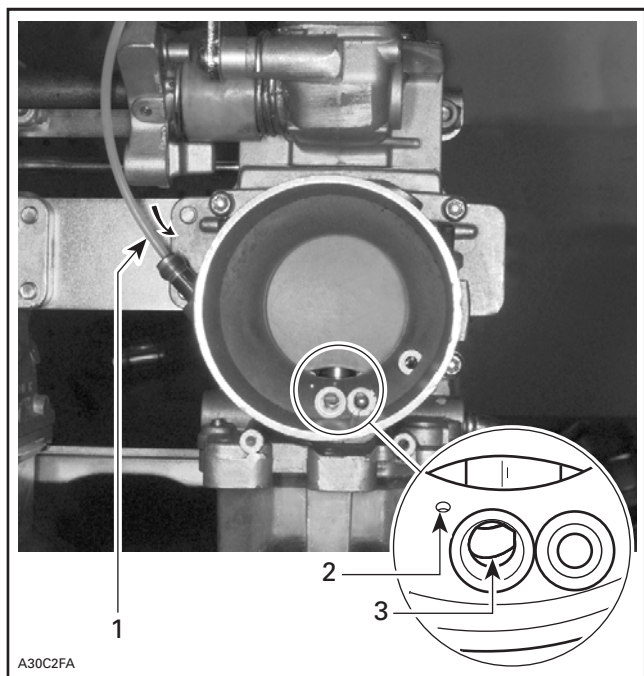
1. Nylon wire no. 21
2. Hole to block
3. Nylon wire seen through screw hole

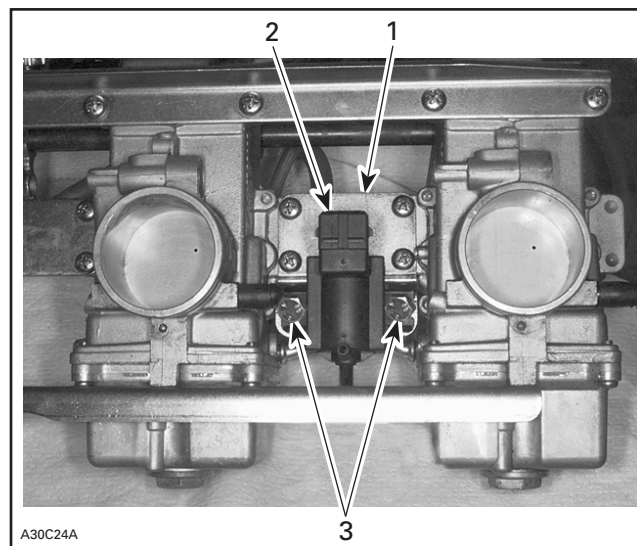
Secure solenoid valve no. 2 to solenoid plate using 2 self-tapping screws no. 4. Tighten at 2.7 to 3 N•m (24 to 27 lbf•in). Refer to following photo.

1. Solenoid plate
2. Solenoid valve
3. Self-tapping screws no. 4

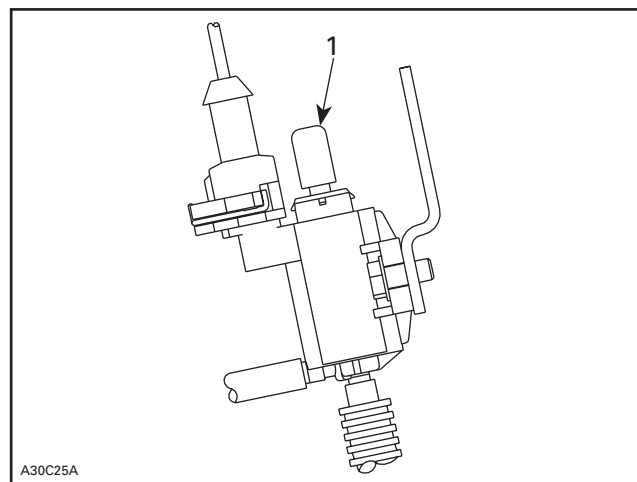
1. This outlet fitting **must be plugged up**

Top outlet fitting on solenoid valve **must be plugged up** or fuel may exit and cause damage. Fuel is flammable and explosive under certain conditions. Always wipe off any fuel or oil spillage from the vehicle. Ensure work area is well ventilated. Do not smoke or allow open flames or sparks in the vicinity.

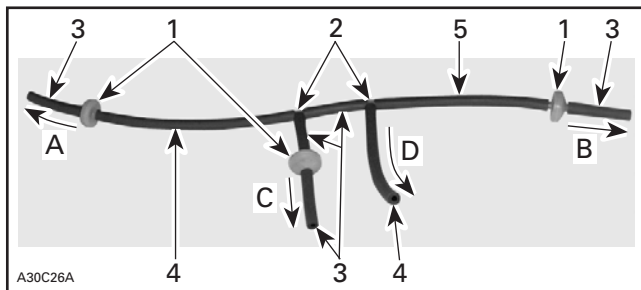
- 1. Check valve (3)
- 2. T-fitting (2)
- 3. 41 mm (1-39/64 in) length hose (5)
- 4. 135 mm (5-5/16 in) length hose (2)
- 5. 110 mm (4-21/64 in) length hose (1)
- A. To MAG side carburetor
- B. To PTO side carburetor
- C. To CTR carburetor
- D. To solenoid valve

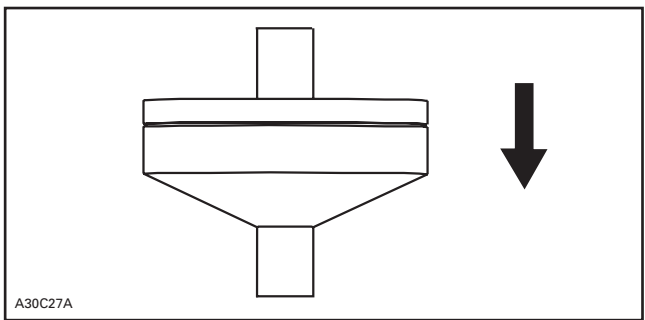
ARROW SHOWS DIRECTION OF GAS FLOW TOWARDS CARBURETORS

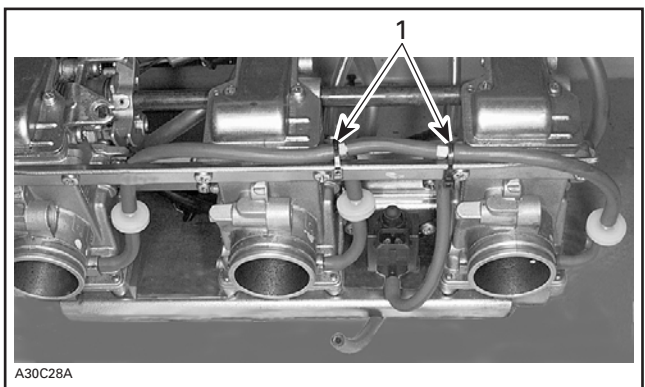
NOTE: Make sure both locking ties are over T-fittings in order not to kink hose.

1. Locking ties

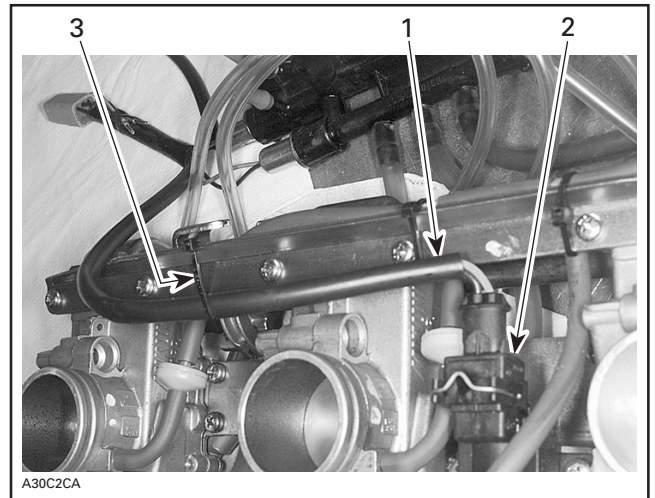
A30C2CA

CAUTION: Do not mix their positioning; BROWN-GREEN wire connects on the same side than BLACK wires connect, while RED-GREEN wire connects on the colored wires side.

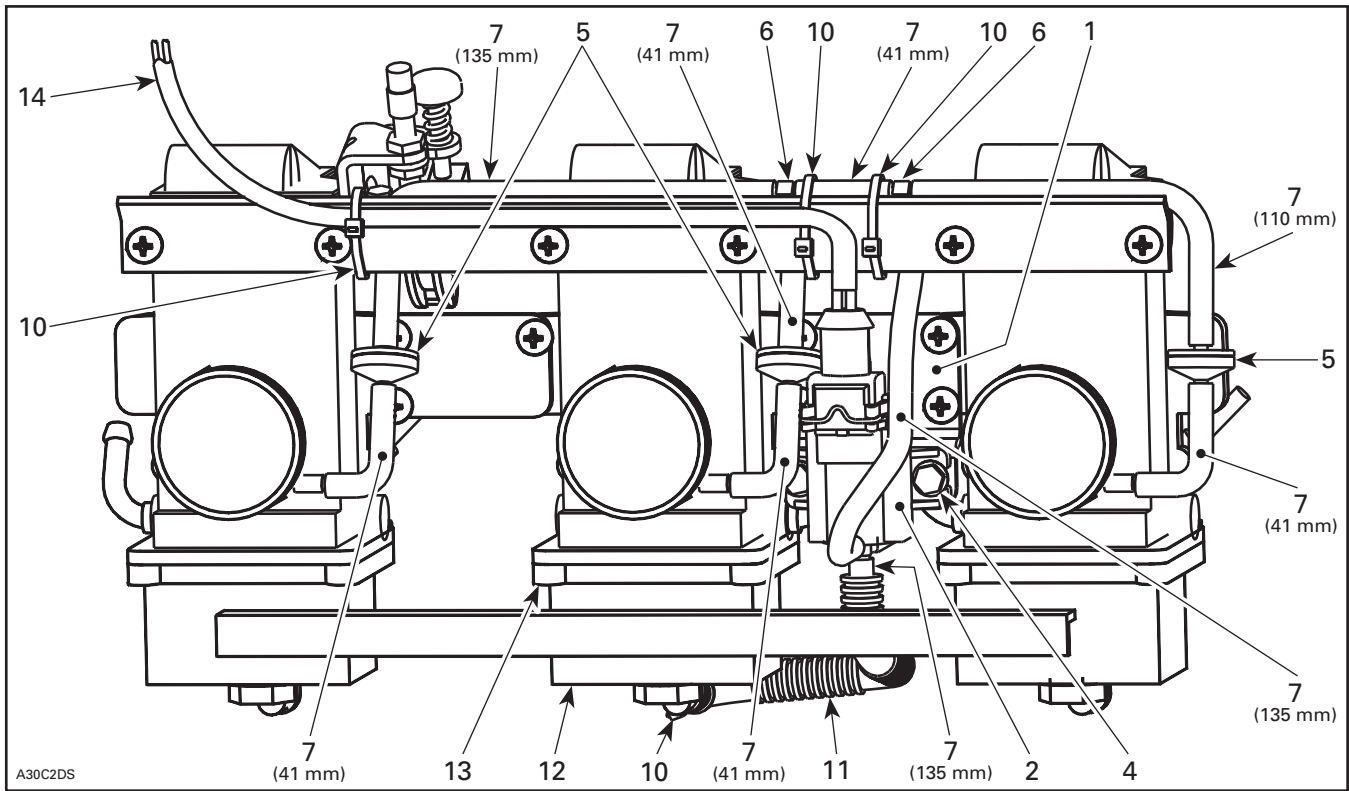
A30C2DS

FINAL INSTALLATION (1999 MODEL YEAR)
NUMBERS REFER TO "PARTS TO BE INSTALLED" LISTING OF PAGE 2

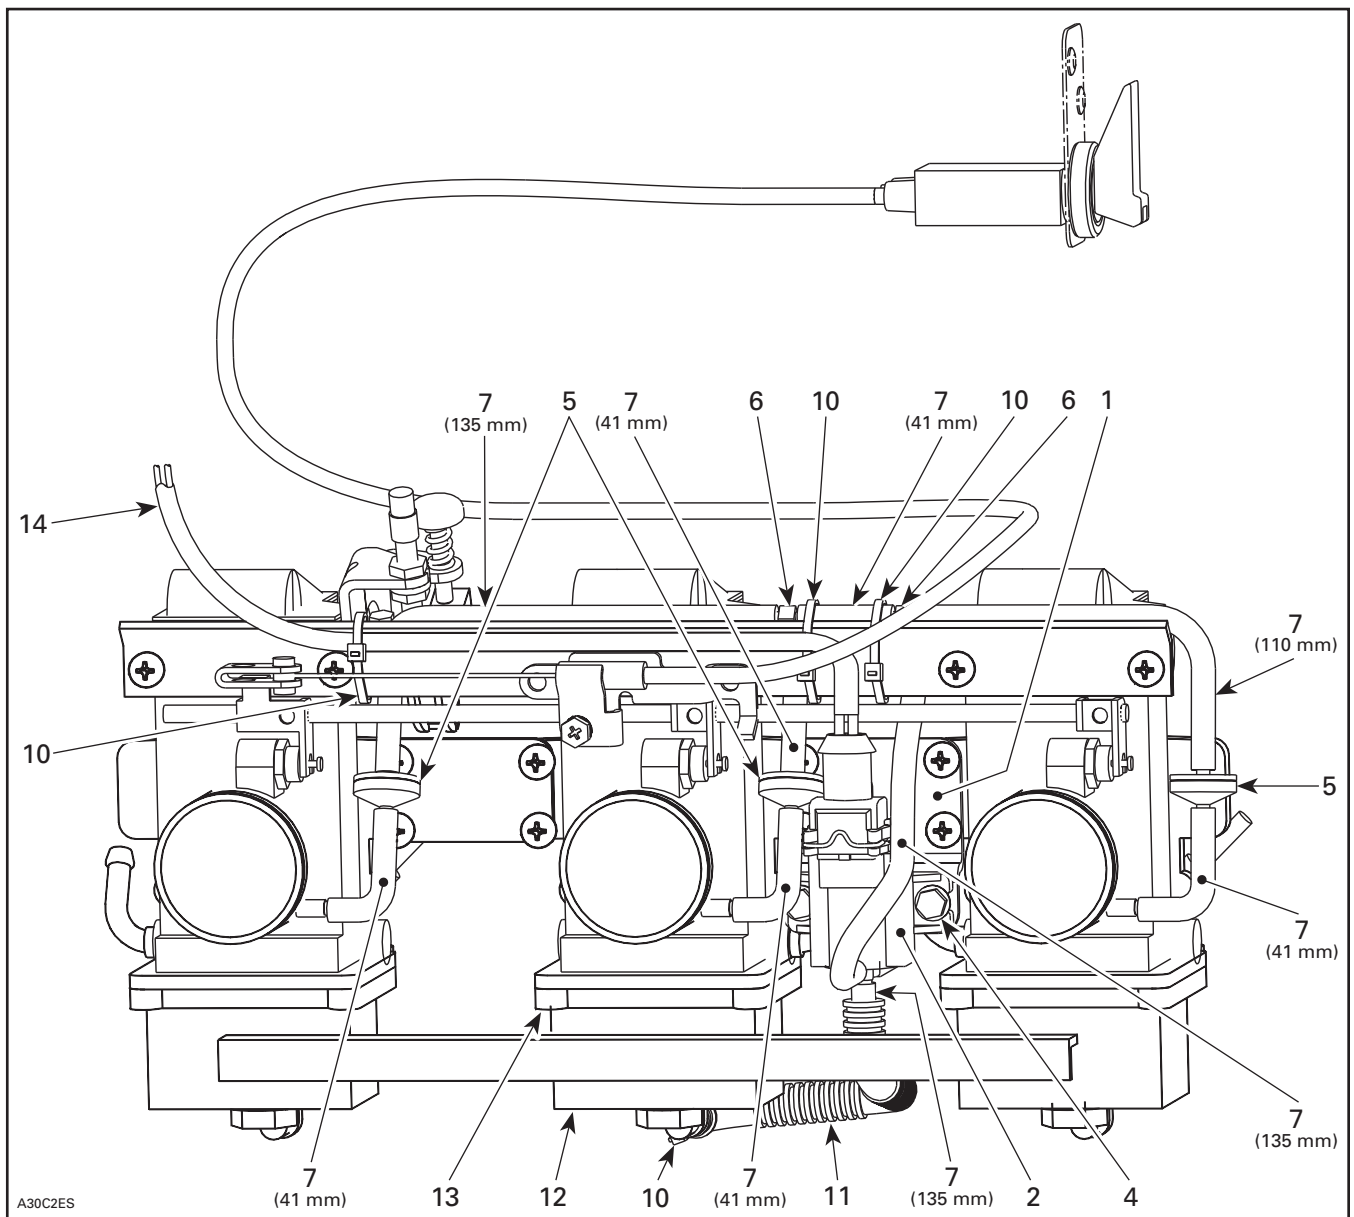
FINAL INSTALLATION (2000 MODEL YEAR)
NUMBERS REFER TO "PARTS TO BE INSTALLED" LISTING OF PAGE 2
