No. **2000-1**

**SUBJECT: Backrest Lock Lever Guides
Premature Rust**

No. **2000-2**

SUBJECT: Belt Guard Bracket

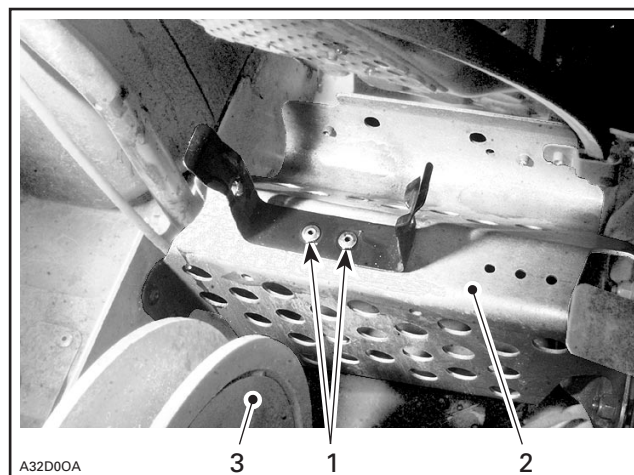
On some units, belt guard rear bracket is too brittle and may break when belt guard is installed or removed.

1. Rivets to be drilled
2. Footrest
3. Driven Pulley

Drill both rivets securing rear bracket.

Remove bracket and keep reinforcement plate.

Make sure surface of footrest receiving belt guard bracket is plane.

Secure new bracket and reinforcement with rivets (P/N 390 402 200).

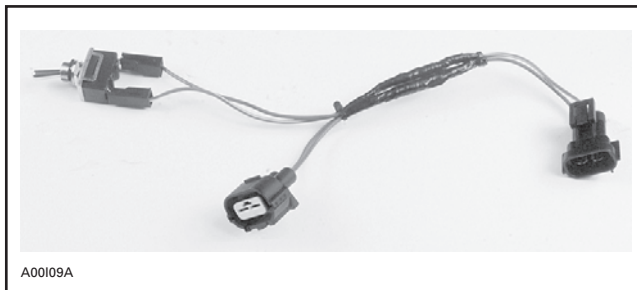
We strongly recommend the use of the by-pass wire (P/N 529 033 300), (refer to following illustration), **instead of starting engine** in order to reduce the chances of data transfer problems.

CONNECT BOTH BY-PASS WIRE TERMINAL HOUSINGS TO HARNESS AND MODULE AND TURN ON THE SWITCH

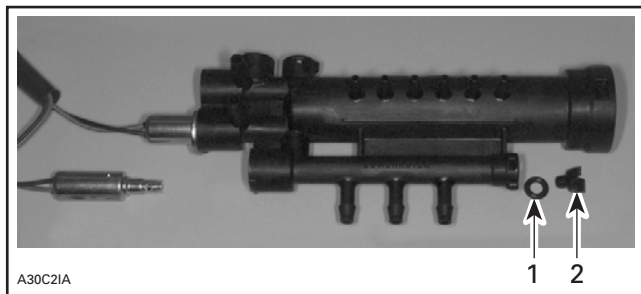
Insert DPM vacuum collector end cap O-ring **no. 17** onto DPM vacuum collector end cap **no. 16**. Align cap dot with solenoid body groove and push it in its hole till it snaps in place.

1. End cap O-ring no. 17
2. End cap no. 16

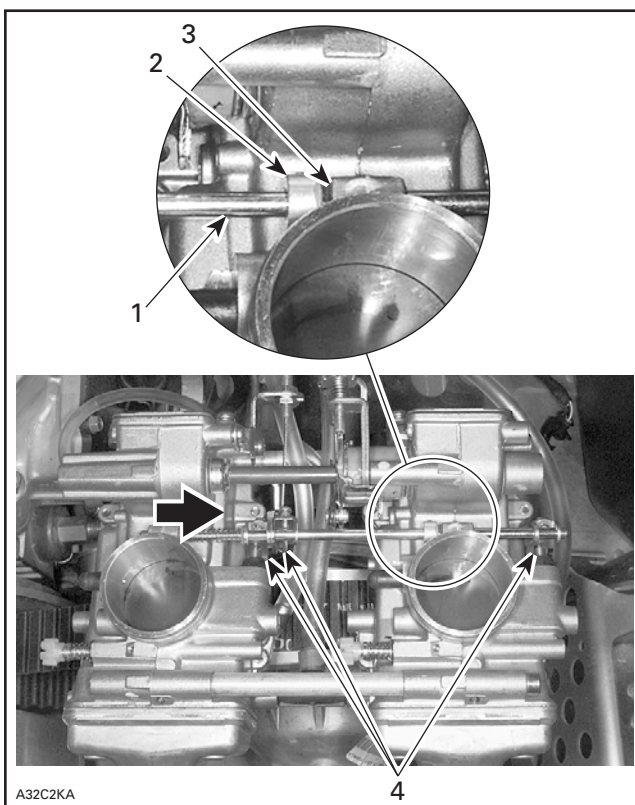
Before reaching PTO side carburetor, insert **new ring**, secure same with **new set screw** properly indexed, (apply Loctite[†] 243 (blue) on set screw) and **ensure to keep nylon packing which is already there.**

Push shaft till the end, index and tighten all 3 lever screws.

ARROW SHOWS DIRECTION OF INSERTION

1. Shaft
2. Ring
3. Nylon packing already there
4. Levers
