Subject: **MX Z X 440®  
Calibration/Warranty†**

No. **2005-2**

Subject: **600 HO SDI Recalibration Update**

No. **2005-3**

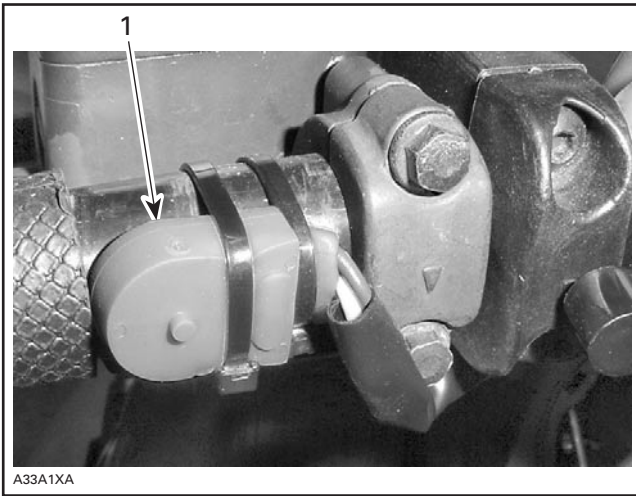
[1] Pipe preheat switch.

- Remove front and rear screws [1] retaining dash panel and remove dash panel.

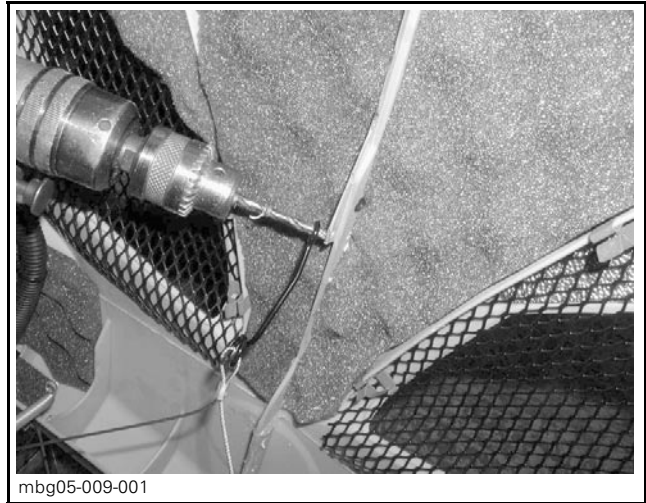
Replace the retainer cable support reinforcing plate on the hood rib.

- Open hood and secure it in its open position with another cable.
- Drill the reinforcing plate rivets.

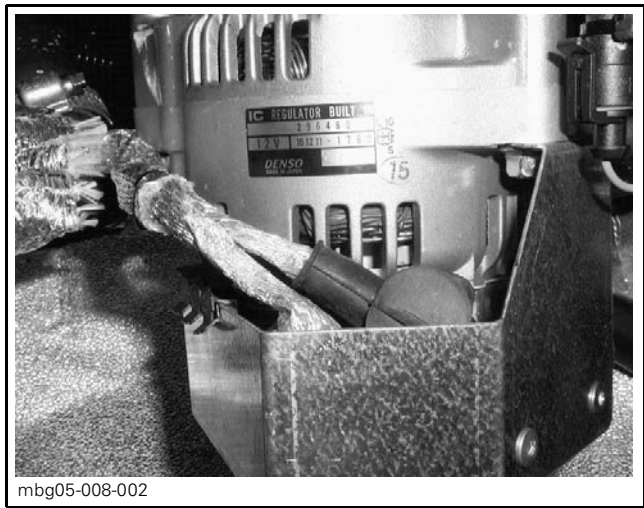
mbg05-008-002

The alternator harness routing may be incorrect. The wires may be too close to the heat shield.

If the wires position looks like this, do the following procedure.

- On the alternator, loosen the red cable retaining nut.
- Turn all wires clockwise (toward engine).
- Secure the wires together with a tie rap to get the correct alternator harness routing: the wires are more toward the engine.

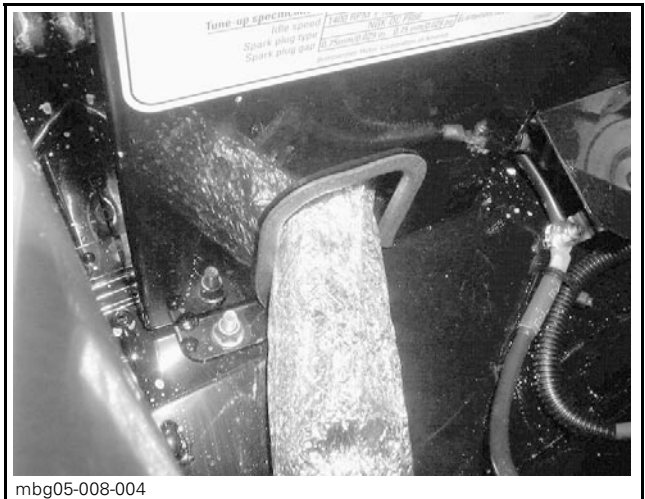
mbg05-008-004

The water hose from the coolant reservoir to engine thermostat housing may get damaged when routing through the heat shield opening.

Install edge protector as shown.

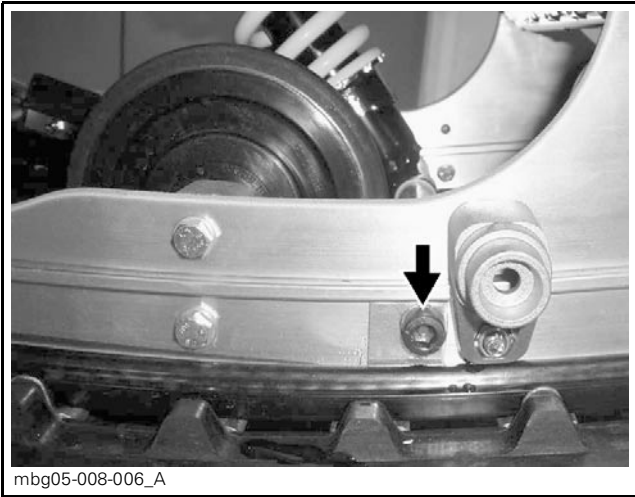
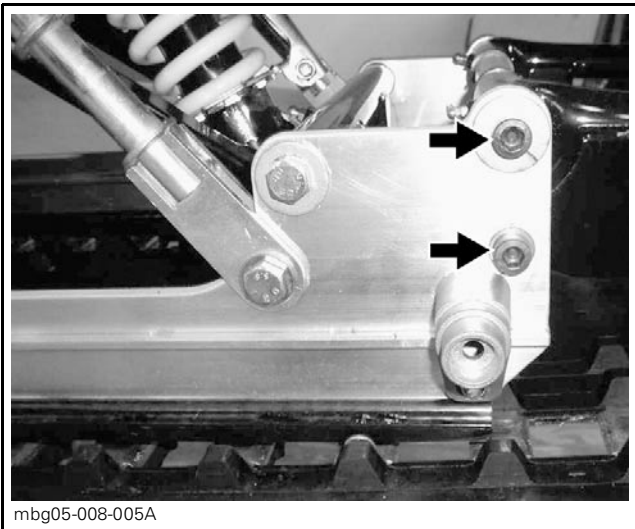
- Remove support wheels on both sides.
- Check rear axle and center shock support axle retaining screws. Using a torque wrench,

look for any screw that would turn before reaching 80 N•m (59 lbf•ft).

- One at a time, out of spec screws must be loosened to 25 mm (1 in) out from the surface of the slide rail (do not remove).
- Apply Loctite 271 (red) (P/N 290 800 005) on threads.
- Torque to 80 N•m (59 lbf•ft).
- Install support wheels and tighten screws to 24 N•m (18 lbf•ft).

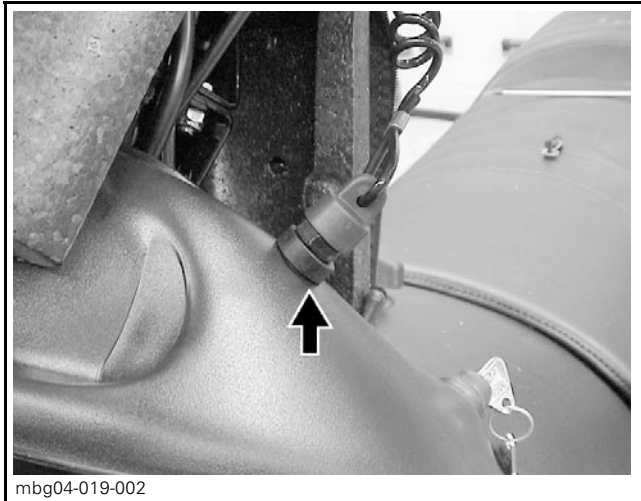
On some vehicle, the rear console may be cracked, because of a wrong tether cut-out switch installation.

- Disconnect the battery if so equipped: black negative first, red positive last.
- Remove the tether cut-out switch.

- Replace the rear console only if it is cracked.

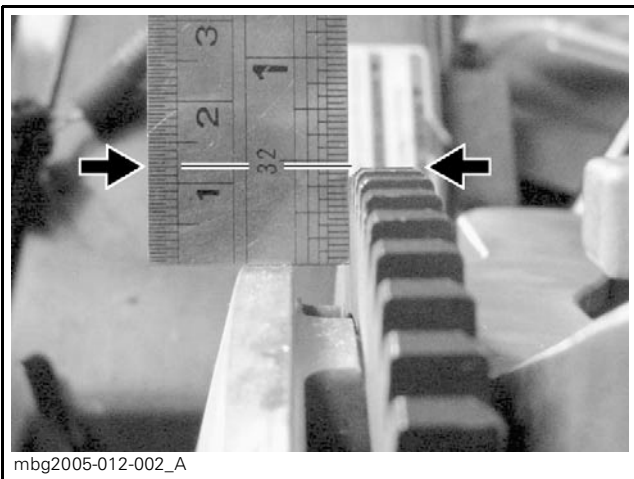
mbg2005-012-002\_A

Appropriate Ring Gear  
Measurement:

- Do not replace an appropriate ring gear.
- Do a warranty claim for "Inspection Only".

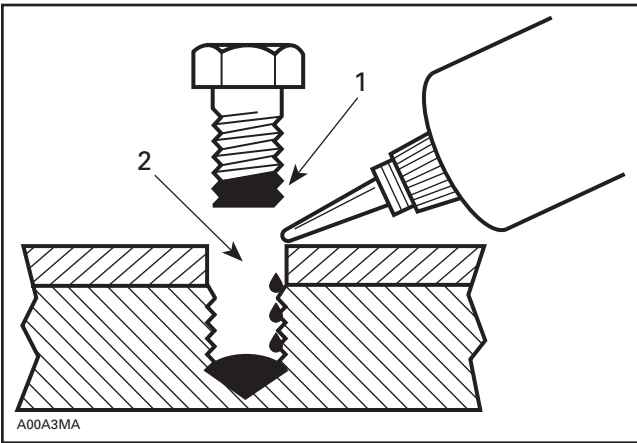
**⚠ WARNING**  
 Failing to use Loctite 271 on screw threads may cause damage that could lead to injury or death.

- Apply Loctite<sup>†</sup> 271 (red) (P/N 293 800 005) on screw threads [1], on hole threads and at the bottom of holes [2].

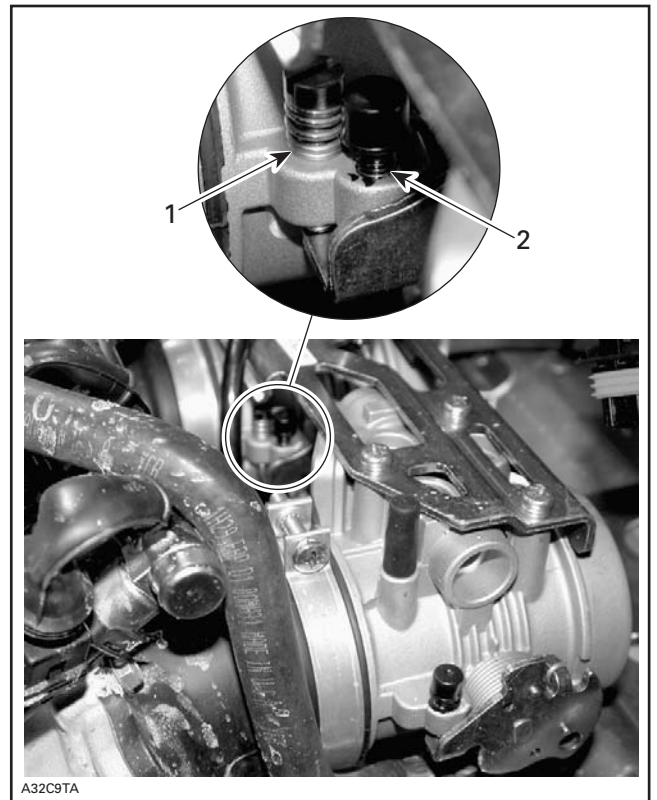
**CAUTION:** Never attempt to adjust the zero position stopper screw [2] (the capped one) or the idle speed adjustment would be impaired. Besides, no adjustment could be performed by the dealer nor the factory to correct the zero position stopper screw. The throttle body would need to be replaced.

- Unscrew idle speed screw [1] until the throttle body plate stop lever rest against its zero position stopper screw [2] (capped screw). If necessary, loosen the throttle cable. Open throttle approximately one quarter then quickly release. Repeat 2 - 3 times to settle throttle plate.
- Push the **Reset** button in the **Setting** section of B.U.D.S.
- Click "OK" on the message box.
- Remove the DESS key when the message box says to do so.
- Reinstall the DESS key when the message is gone.
- The throttle opening displayed in B.U.D.S. should be 0.00 (0.1 maximum).
- If TPS is not within the allowed range while resetting the **Closed Throttle**, the

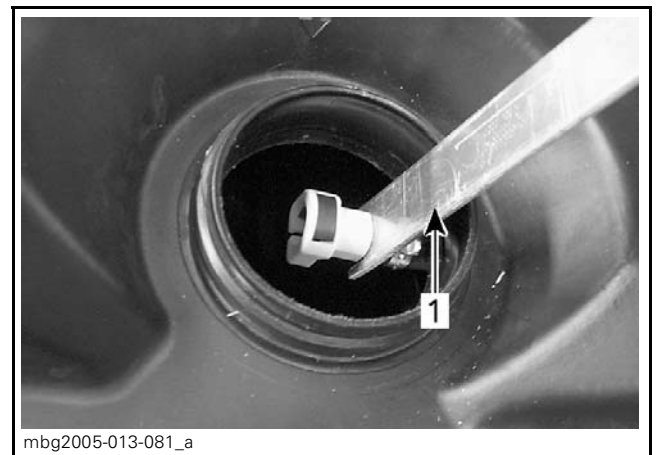
**CAUTION:** Multi pick up screen [2] must face bottom of fuel tank.

- Attach hose quick connect to quick connect fitting [P2], using special tool [1] .

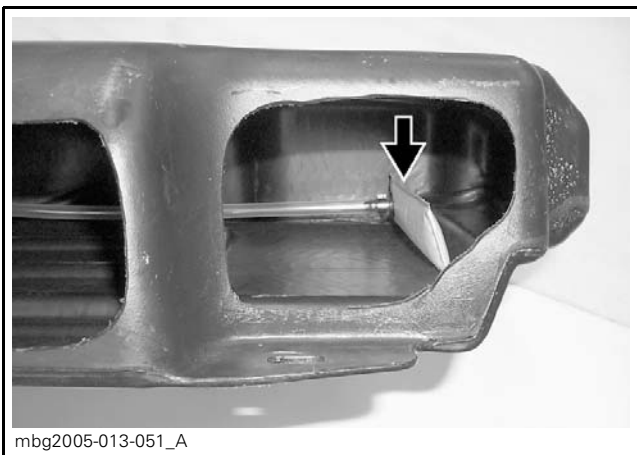
**CAUTION:** Filter sock must rest flat at the bottom of fuel tank.

**CAUTION:** Be sure to hear a “click” when connecting the quick connect fittings. Push pull on the quick connect fitting to ensure connection is well secured in place.

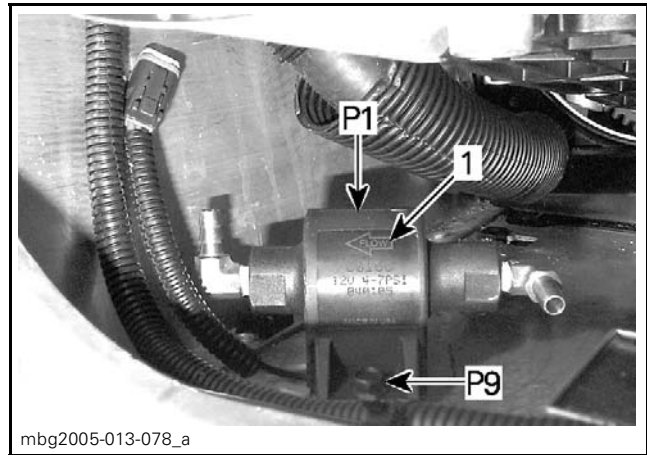
**CAUTION:** The arrow must point toward the rear [1] of the vehicle.

- Install electric fuel pump [P1] and secure with self-tapping screws [P9] .

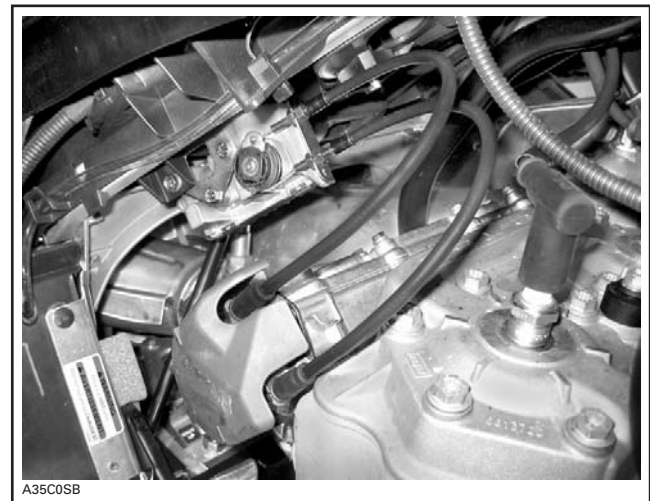
This is the correct position:

- Tighten nut of each cable to E-RAVE shaft pulley bracket.
- Ensure cables are parallel to each other.

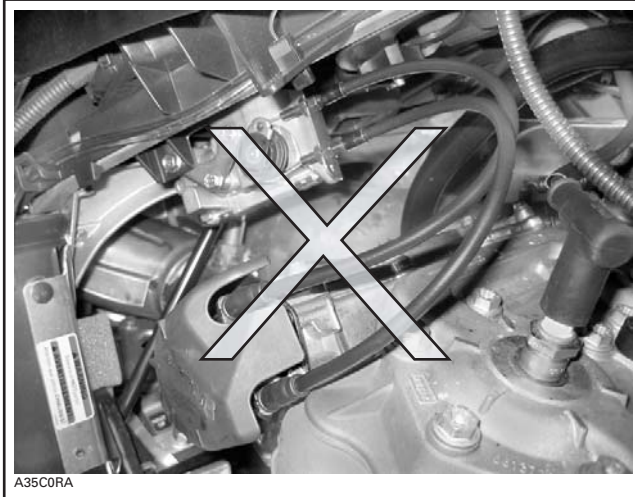
Example of wrong position:

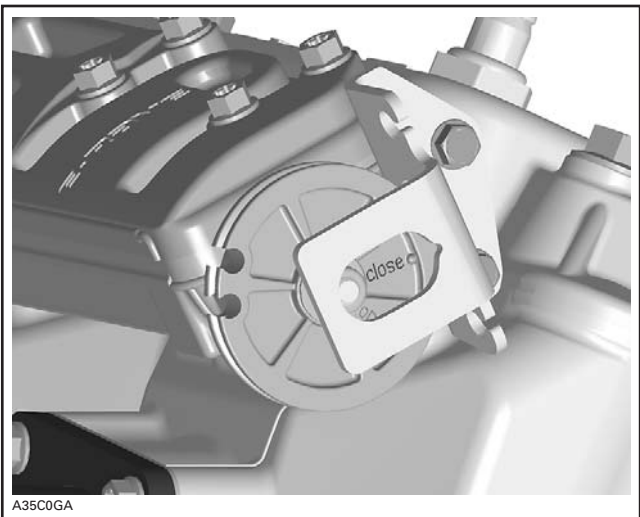
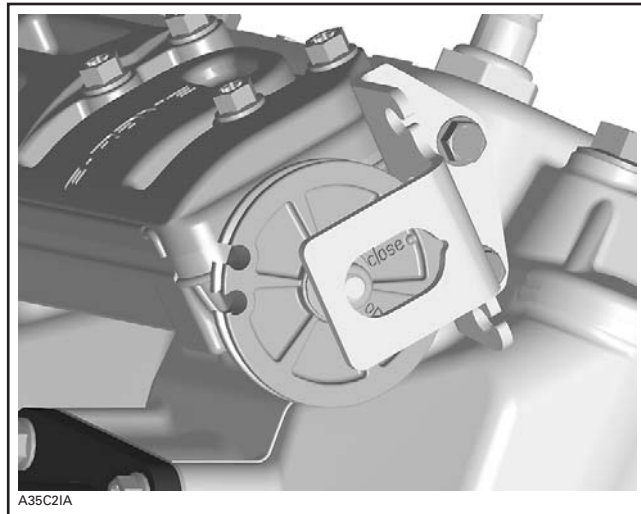
A35C0GA

**CAUTION:** The installation and adjustment of the E-RAVE cables is critical. If the cables are installed when the actuator is at its mechanical stop position. (As when the engine is started with no cables installed). The E-RAVEs will not function, the ECM will revert to the open fuel map (richer), the check engine light will NOT illuminate, NO code will be set and the engine will not reach top operating RPM.

- Readjust top (closing) cable as necessary.
- Remove relay jumper.
- Tighten bottom cable adjuster [1] (opening cable) to remove play in cable.

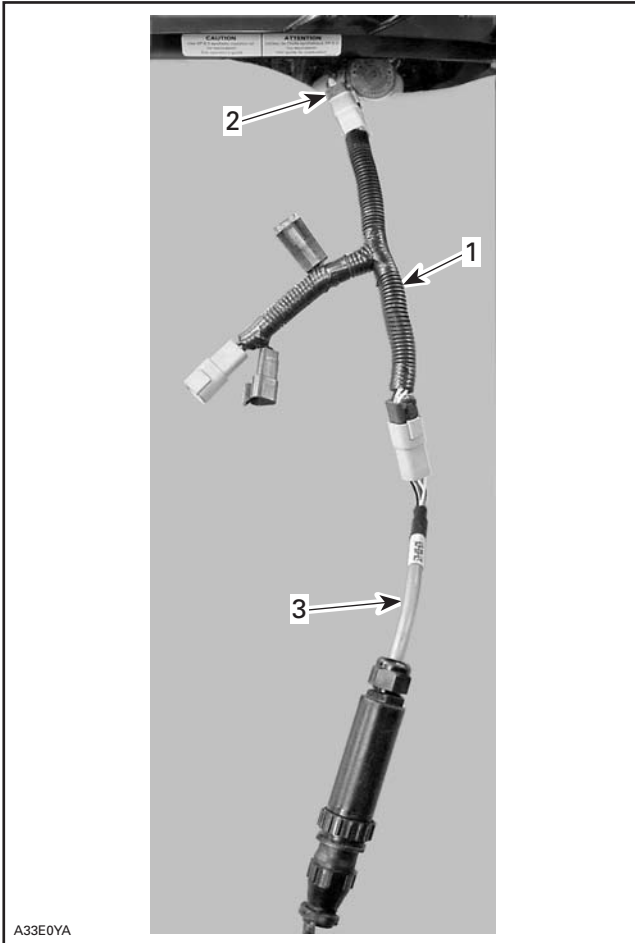
**CAUTION:** If supply harness (P/N 529 035 869) is not used, it will lead to module failure.

- Connect supply harness [1], (P/N 529 035 869), to diagnostic connector [2] located on right side of vehicle, then connect the diagnostic cable [3] to supply harness.

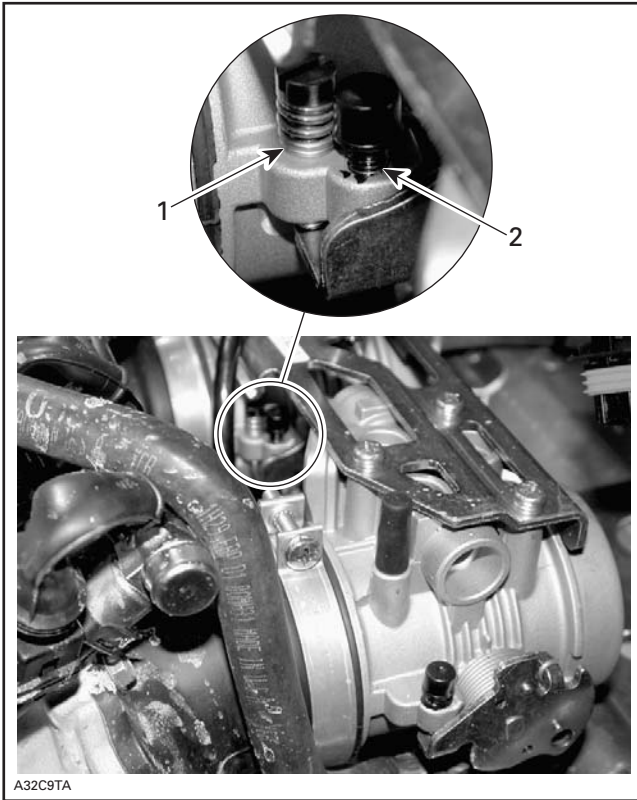
**CAUTION:** Never attempt to adjust the zero position stopper screw [2] (the capped one) or the idle speed adjustment would be impaired. Besides, no adjustment could be performed by the dealer nor the factory to correct the zero position stopper screw. The throttle body would need to be replaced.

- Unscrew idle speed screw [1] until the throttle body plate stop lever rest against its zero position stopper screw [2] (capped screw). If necessary, loosen the throttle cable. Open throttle approximately one quarter then quickly release. Repeat 2 - 3 times to settle throttle plate.
- Push the **Reset** button in the **Setting** section of B.U.D.S.
- Click "OK" on the message box.
- Remove the DESS key when the message box says to do so.
- Reinstall the DESS key when the message is gone.
- The throttle opening displayed in B.U.D.S. should be 0.00 (0.1 maximum).

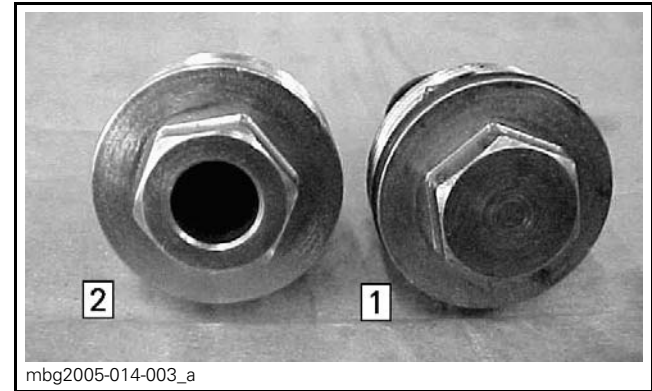
- If TPS is not within the allowed range while resetting the **Closed Throttle**, the ECM will generate a fault code and will not accept the setting.
- Adjust the idle speed screw until B.U.D.S. throttle opening displays the proper TPS value.

1: TPS value with active decompressor (std):	4.9 to 5.0°
2: TPS value with plugged decompressor (opt):	4.6 to 4.7°

- Adjust throttle cable.
- Make sure the wide open throttle is at least 84 %.
- Release fuel pressure using B.U.D.S.
- Disconnect the power adapter harness from the diagnostic port on vehicle.

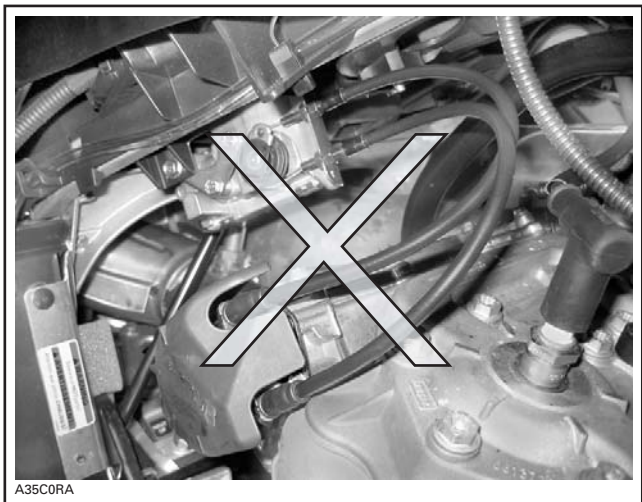
Example of wrong position:

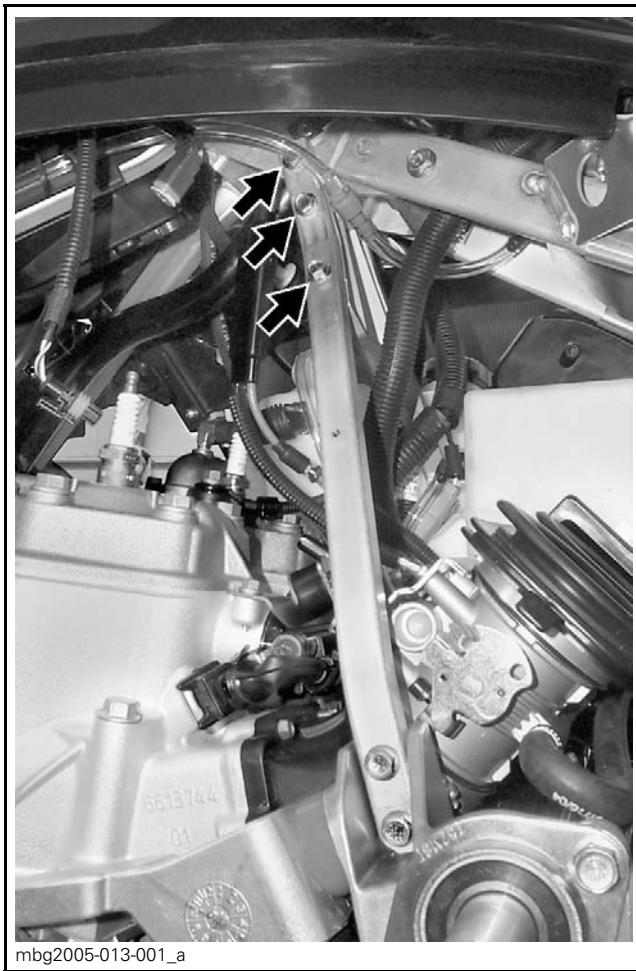
Pyramidal frame bolts may become loose.

Replace existing bolts with new bolts with nylon patch

To maintain hole alignment while replacing the six bolts on top of the pyramidal frame member; remove and replace existing bolts one at a time.

Nylon Patch Bolt Torque	18 N•m (13 lbf•ft)
-------------------------	--------------------

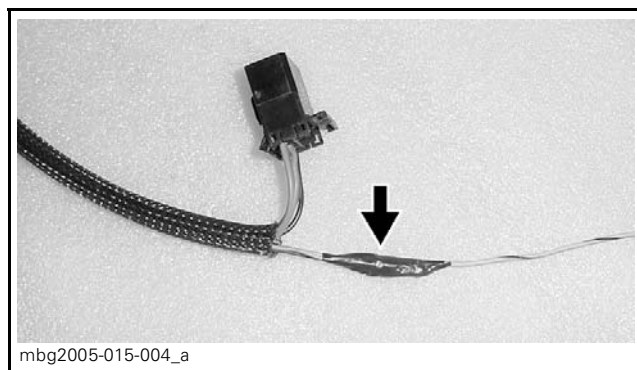
Heated grip element may fail and stop working.

- Cut wires retaining locking tie.
- Remove terminals from connector. Make sure to note the terminals' location to ease installation.
- Tape a 508 mm (20 in) long piece of wire on the terminals. This wire will be used later to pull the new heated element wire back through the protective sleeve.
